**ASSESSMENT OF THE HAWKINSVILLE DAM**  
**ON THE BLACK RIVER**

**BOONVILLE, NEW YORK**

March 12, 2012

MMI #3967-01

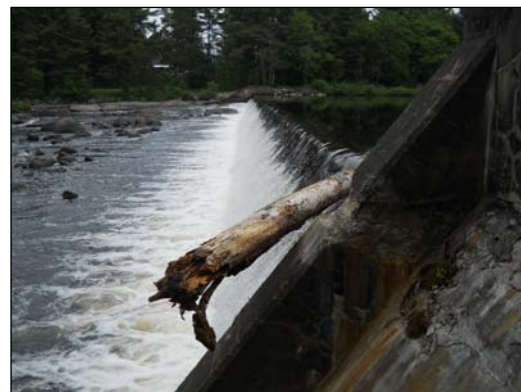
*Photo 1 – The Hawkinsville Dam as viewed from the river-left bank.*

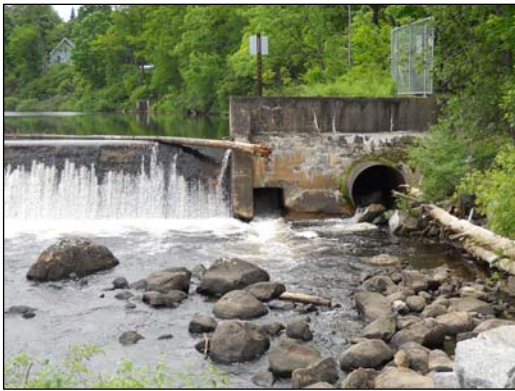
foot diameter steel penstock outlet pipe and a concrete low-level drain, respectively. The gate structure has been filled in, and its operability is not known. The penstock was used to supply water power for the operation of machinery at a mill located downstream on the left bank (see Photo 2). The mill structure has since been demolished and removed; however, concrete portions of the building's foundation remain. The right bank near the dam is composed of a poorly defined man-made earthen embankment, which is lower in elevation than the concrete training walls.

*Photo 2 – Low-level impoundment drain and penstock on river-left bank.*

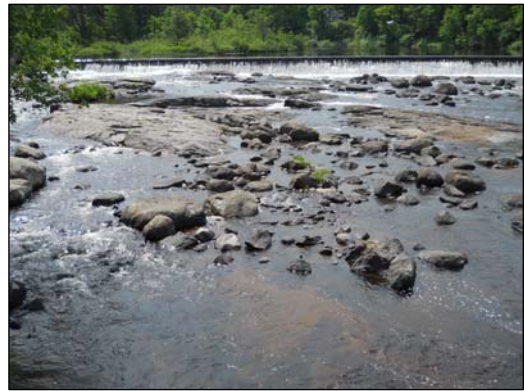
The Hawkinsville Dam is located approximately 315 feet upstream of the Hawkinsville Road (County Road 61/Woodgate Drive) bridge and is situated at the head of a naturally occurring rapids section of the Black River. The dam was constructed on a bedrock outcrop, which forms the rapids (see Photo 3).

*Photo 3 – Ledge outcropping downstream of the Hawkinsville Dam.*

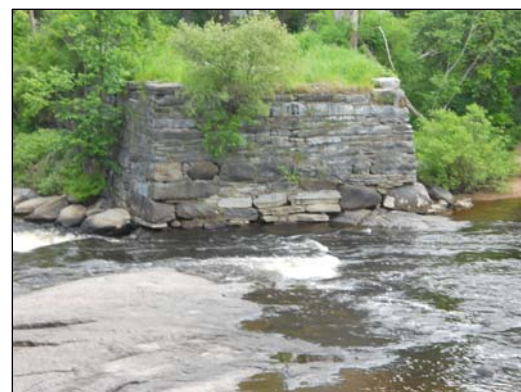
A historic stone masonry bridge abutment is located downstream of the dam on the river-right bank (see Photo 4), which likely supported a bridge that connected Edmonds Road to Hawkinsville Road. The bridge was likely replaced with the more modern bridge carrying Hawkinsville Road over the Black River.

*Photo 4 – Historic bridge abutment downstream of the Hawkinsville Dam, river-right bank.*

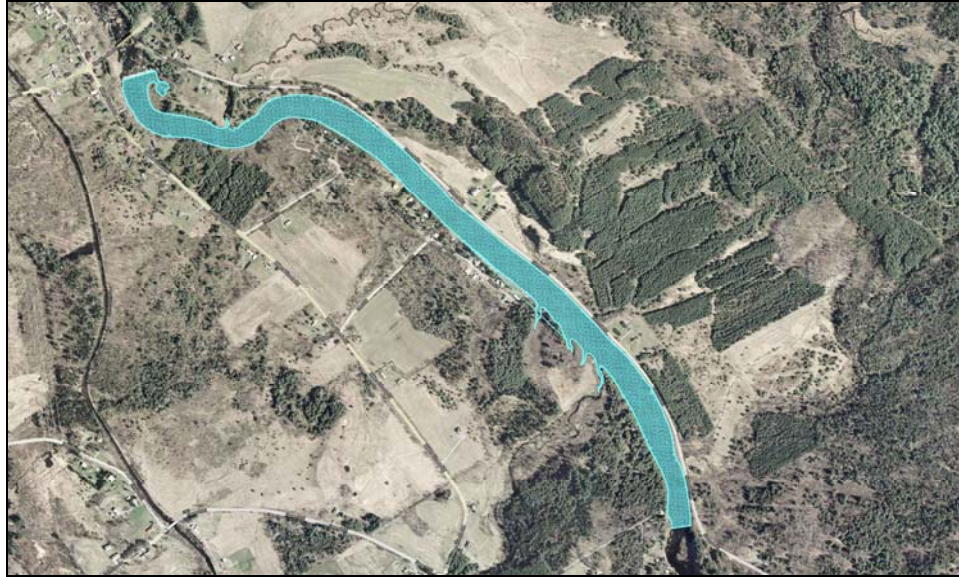
The Hawkinsville Dam impoundment has been reported as being  $\pm 6,340$  feet long, with 1,100 acre-feet of storage between the top of spillway and the top of dam (New York District Corps of Engineers, 1981). Field assessment by MMI staff during normal flow conditions (July 27, 2011), with approximately two inches of water flowing over the spillway, determined that the impoundment extends upstream from the dam approximately 7,000 feet. The upstream end of the impoundment is just downstream of a mid-channel island where supercritical flow was observed through a section of rapids (see Photos 5 and 6).

*Photo 5 – Aerial view of the Hawkinsville Dam impoundment.*

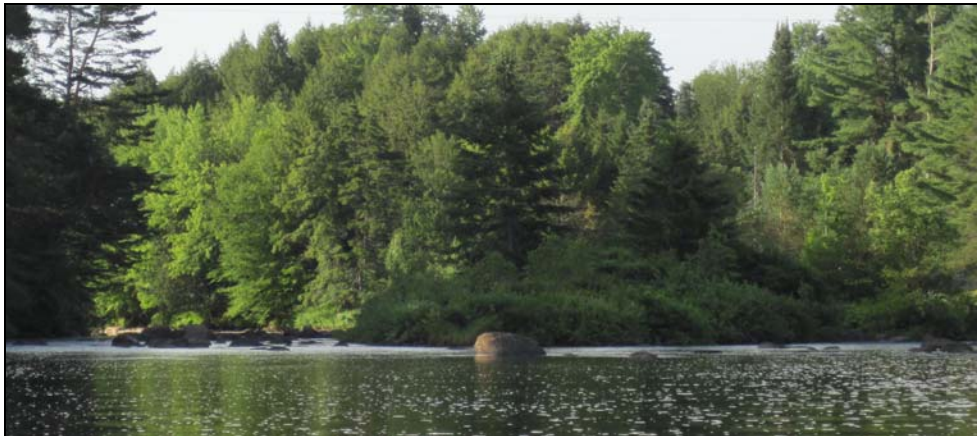
*Photo 6 – Looking upstream at mid-stream island and rapids (upstream end of the impoundment).*

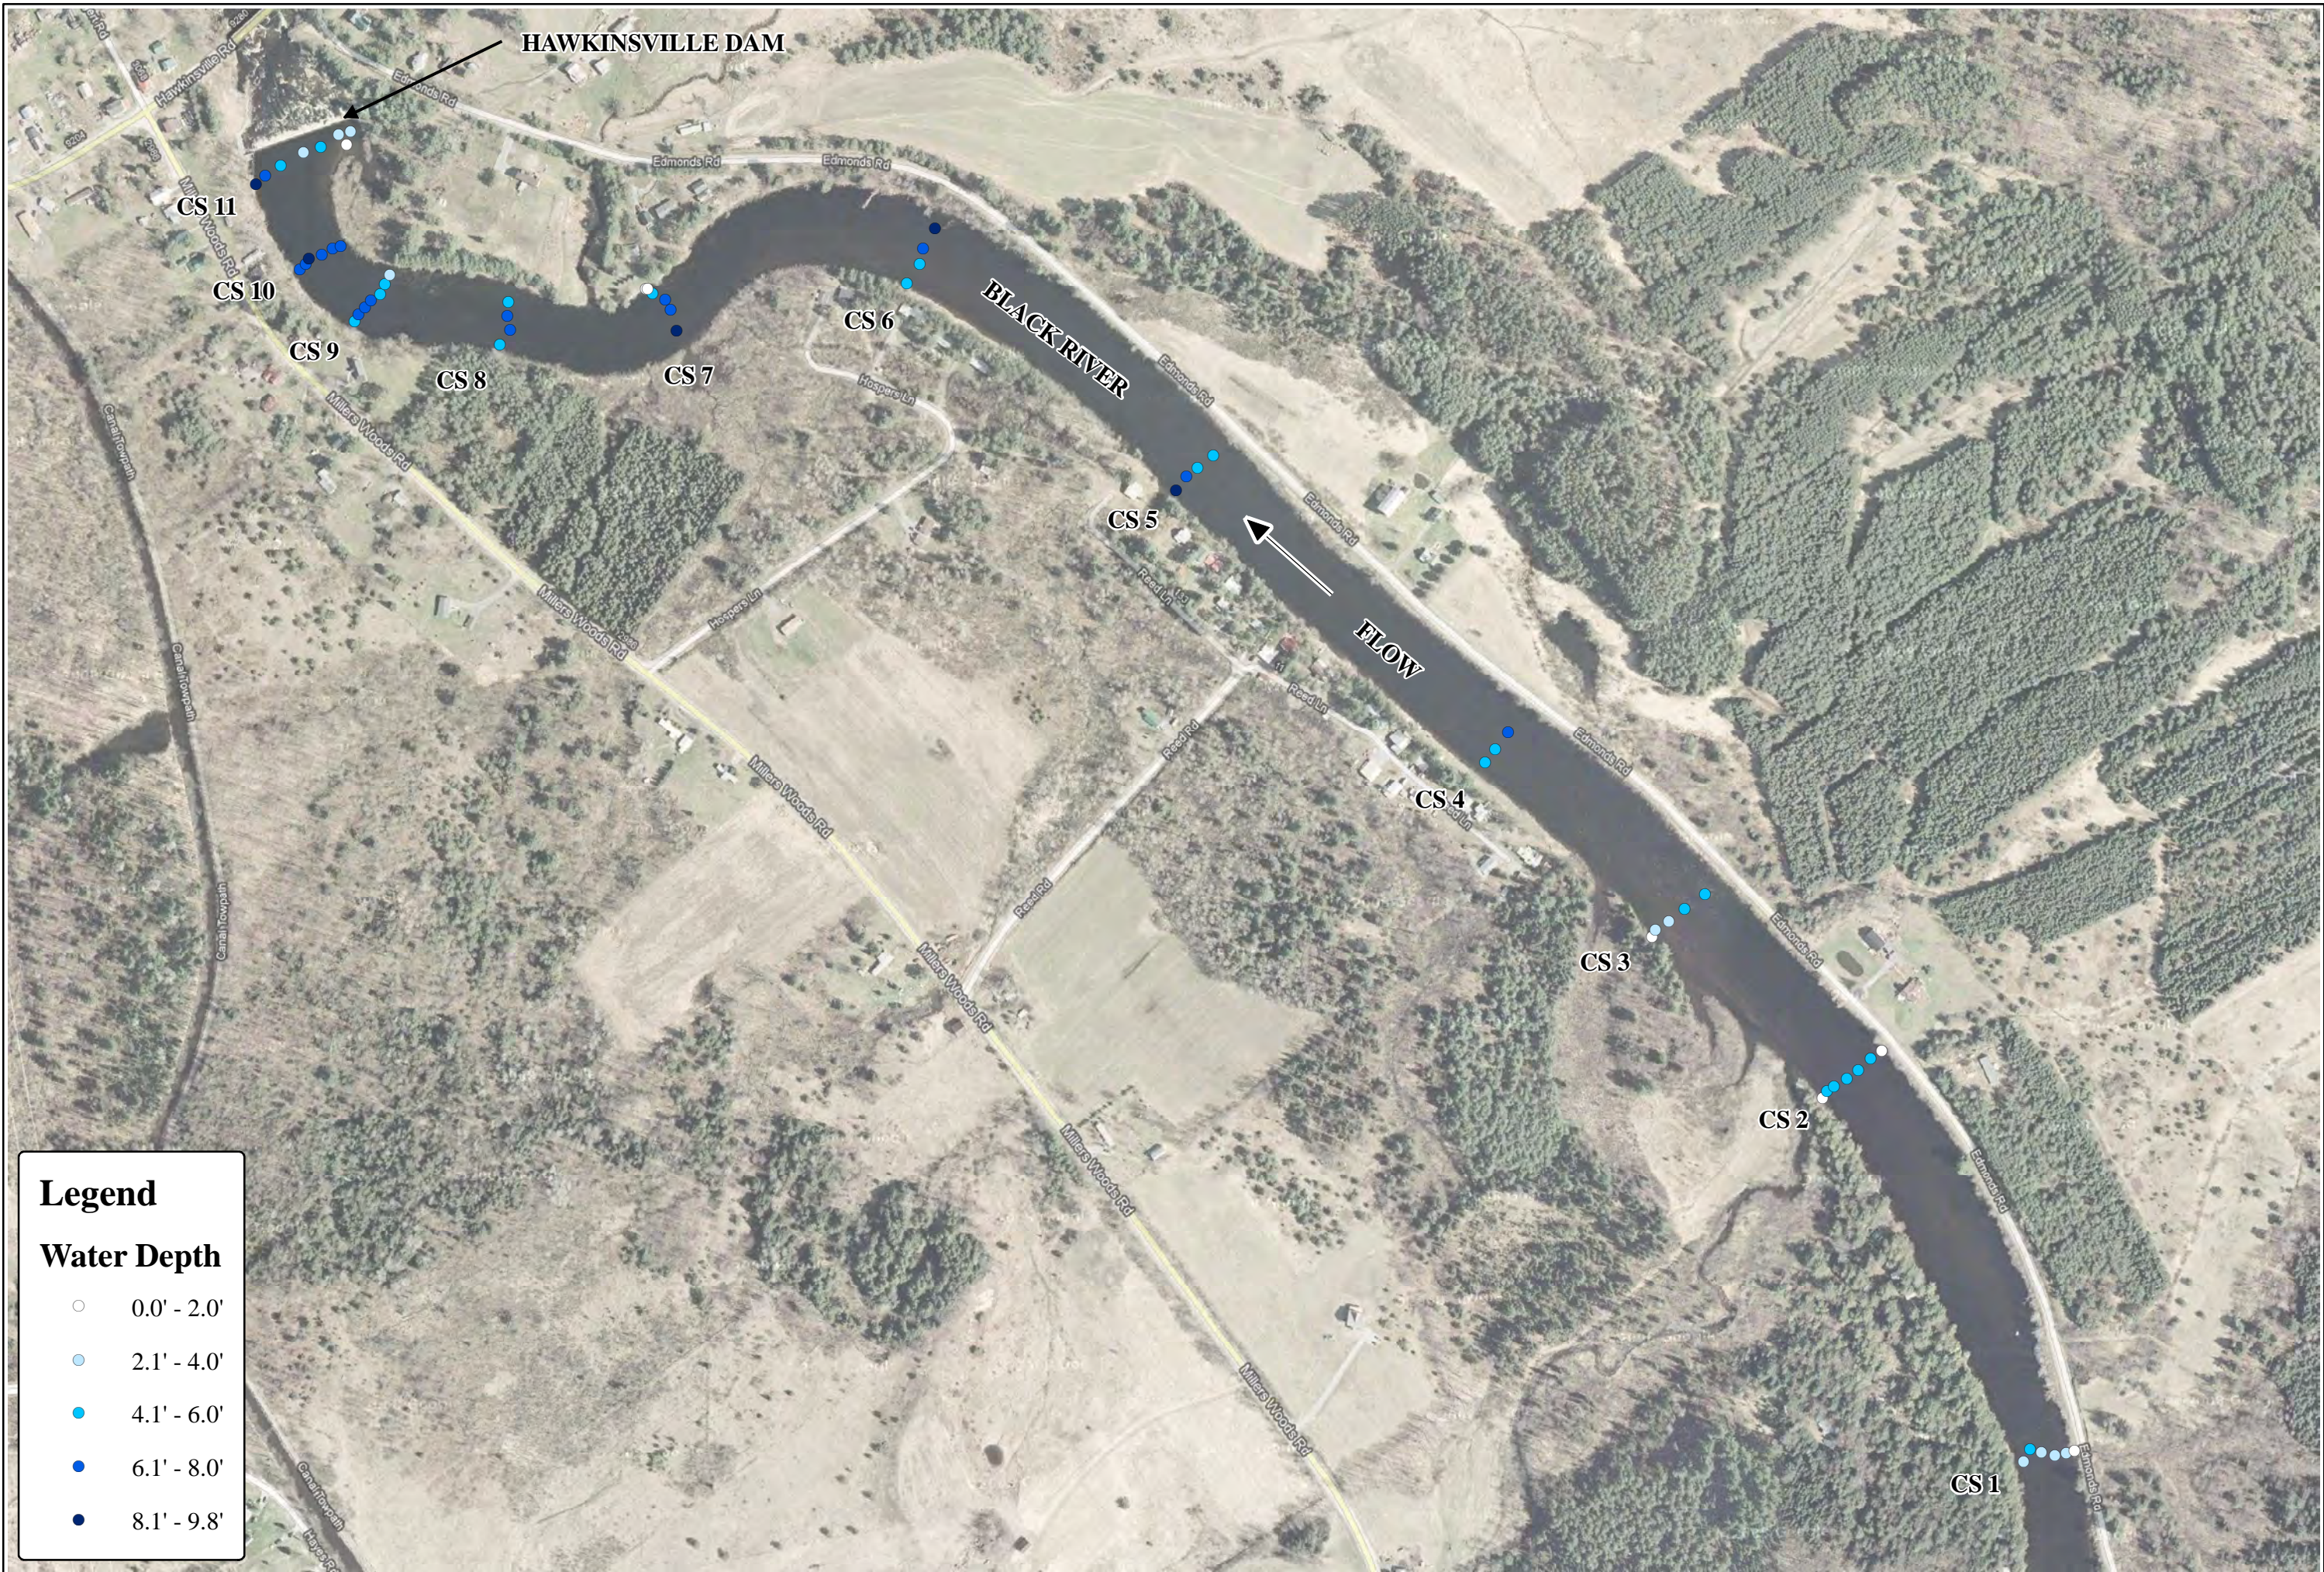
**Figure 3**

Water depths in the impoundment ranged from two to 10 feet. Generally, the deepest water was closest to the dam, extending upstream approximately 2,000 feet, where depths were generally between five and 10 feet.

**SURVEYED WATER DEPTHS (JULY 28, 2011)**  
**ASSESSMENT OF THE HAWKINSVILLE DAM**  
**BLACK RIVER, BOONVILLE, NEW YORK**

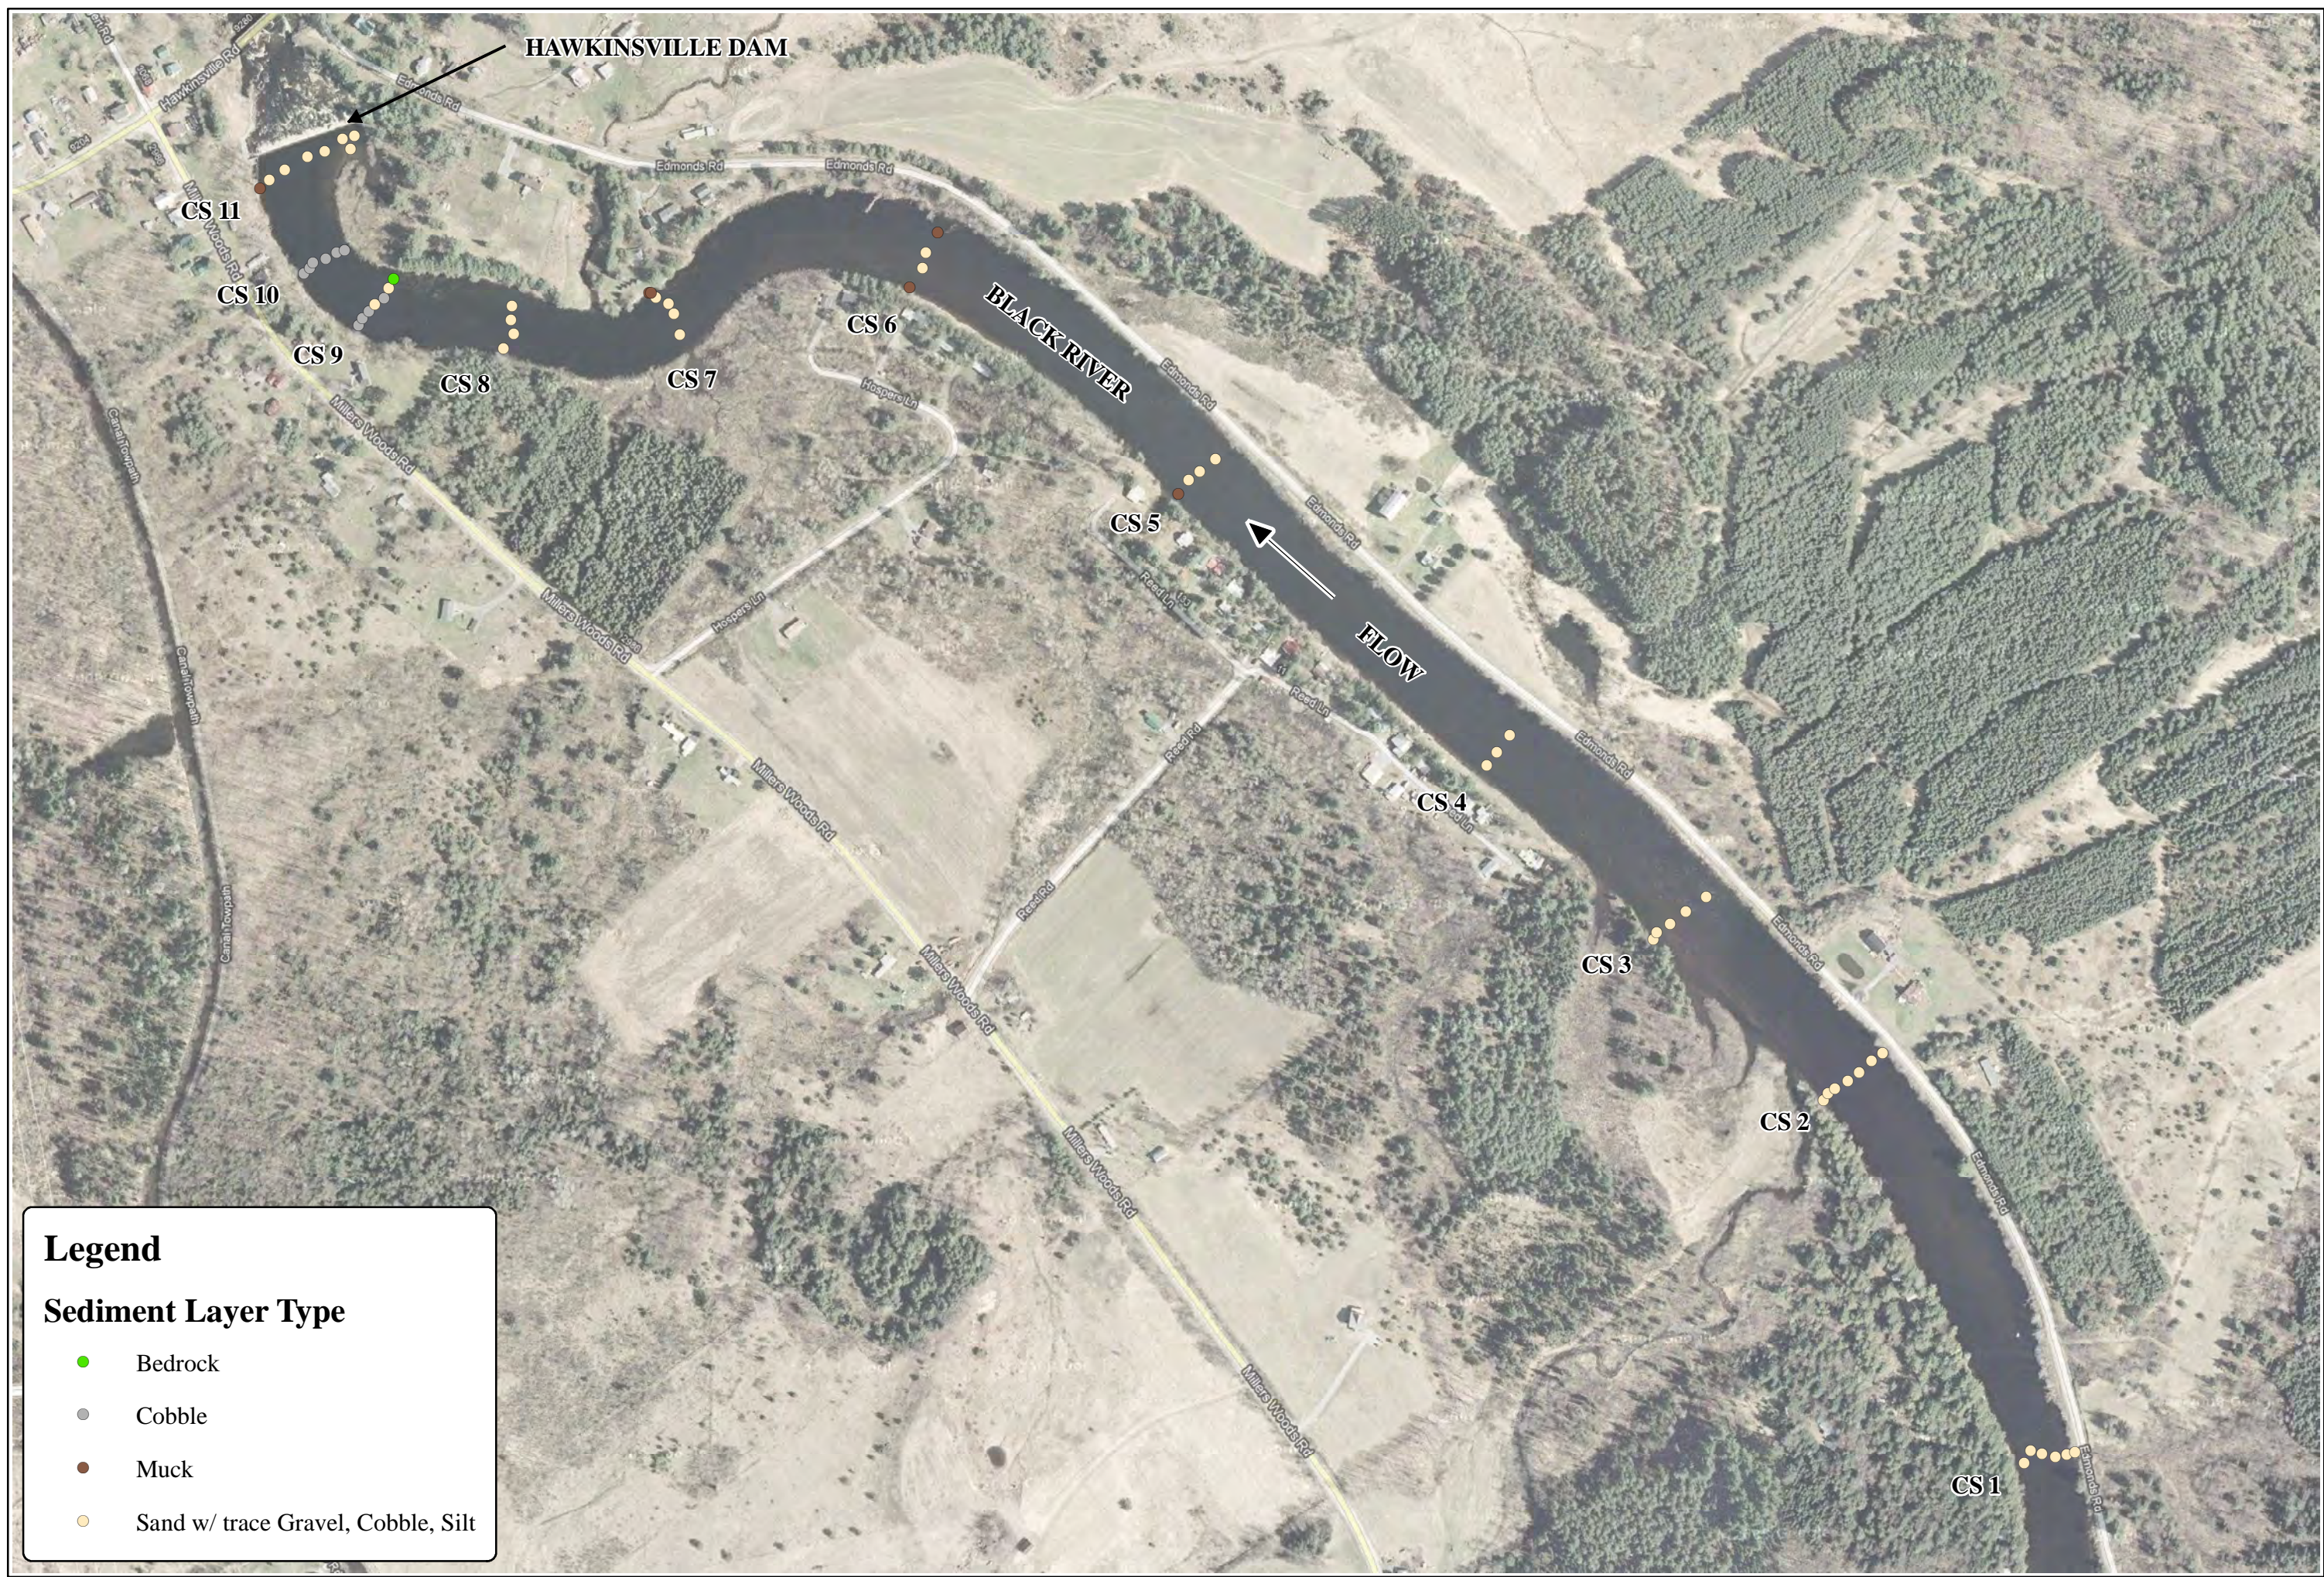
**Figure 4**

**SURVEYED SEDIMENT TYPE (JULY 28, 2011)**  
**ASSESSMENT OF THE HAWKINSVILLE DAM**  
**BLACK RIVER, BOONVILLE, NEW YORK**

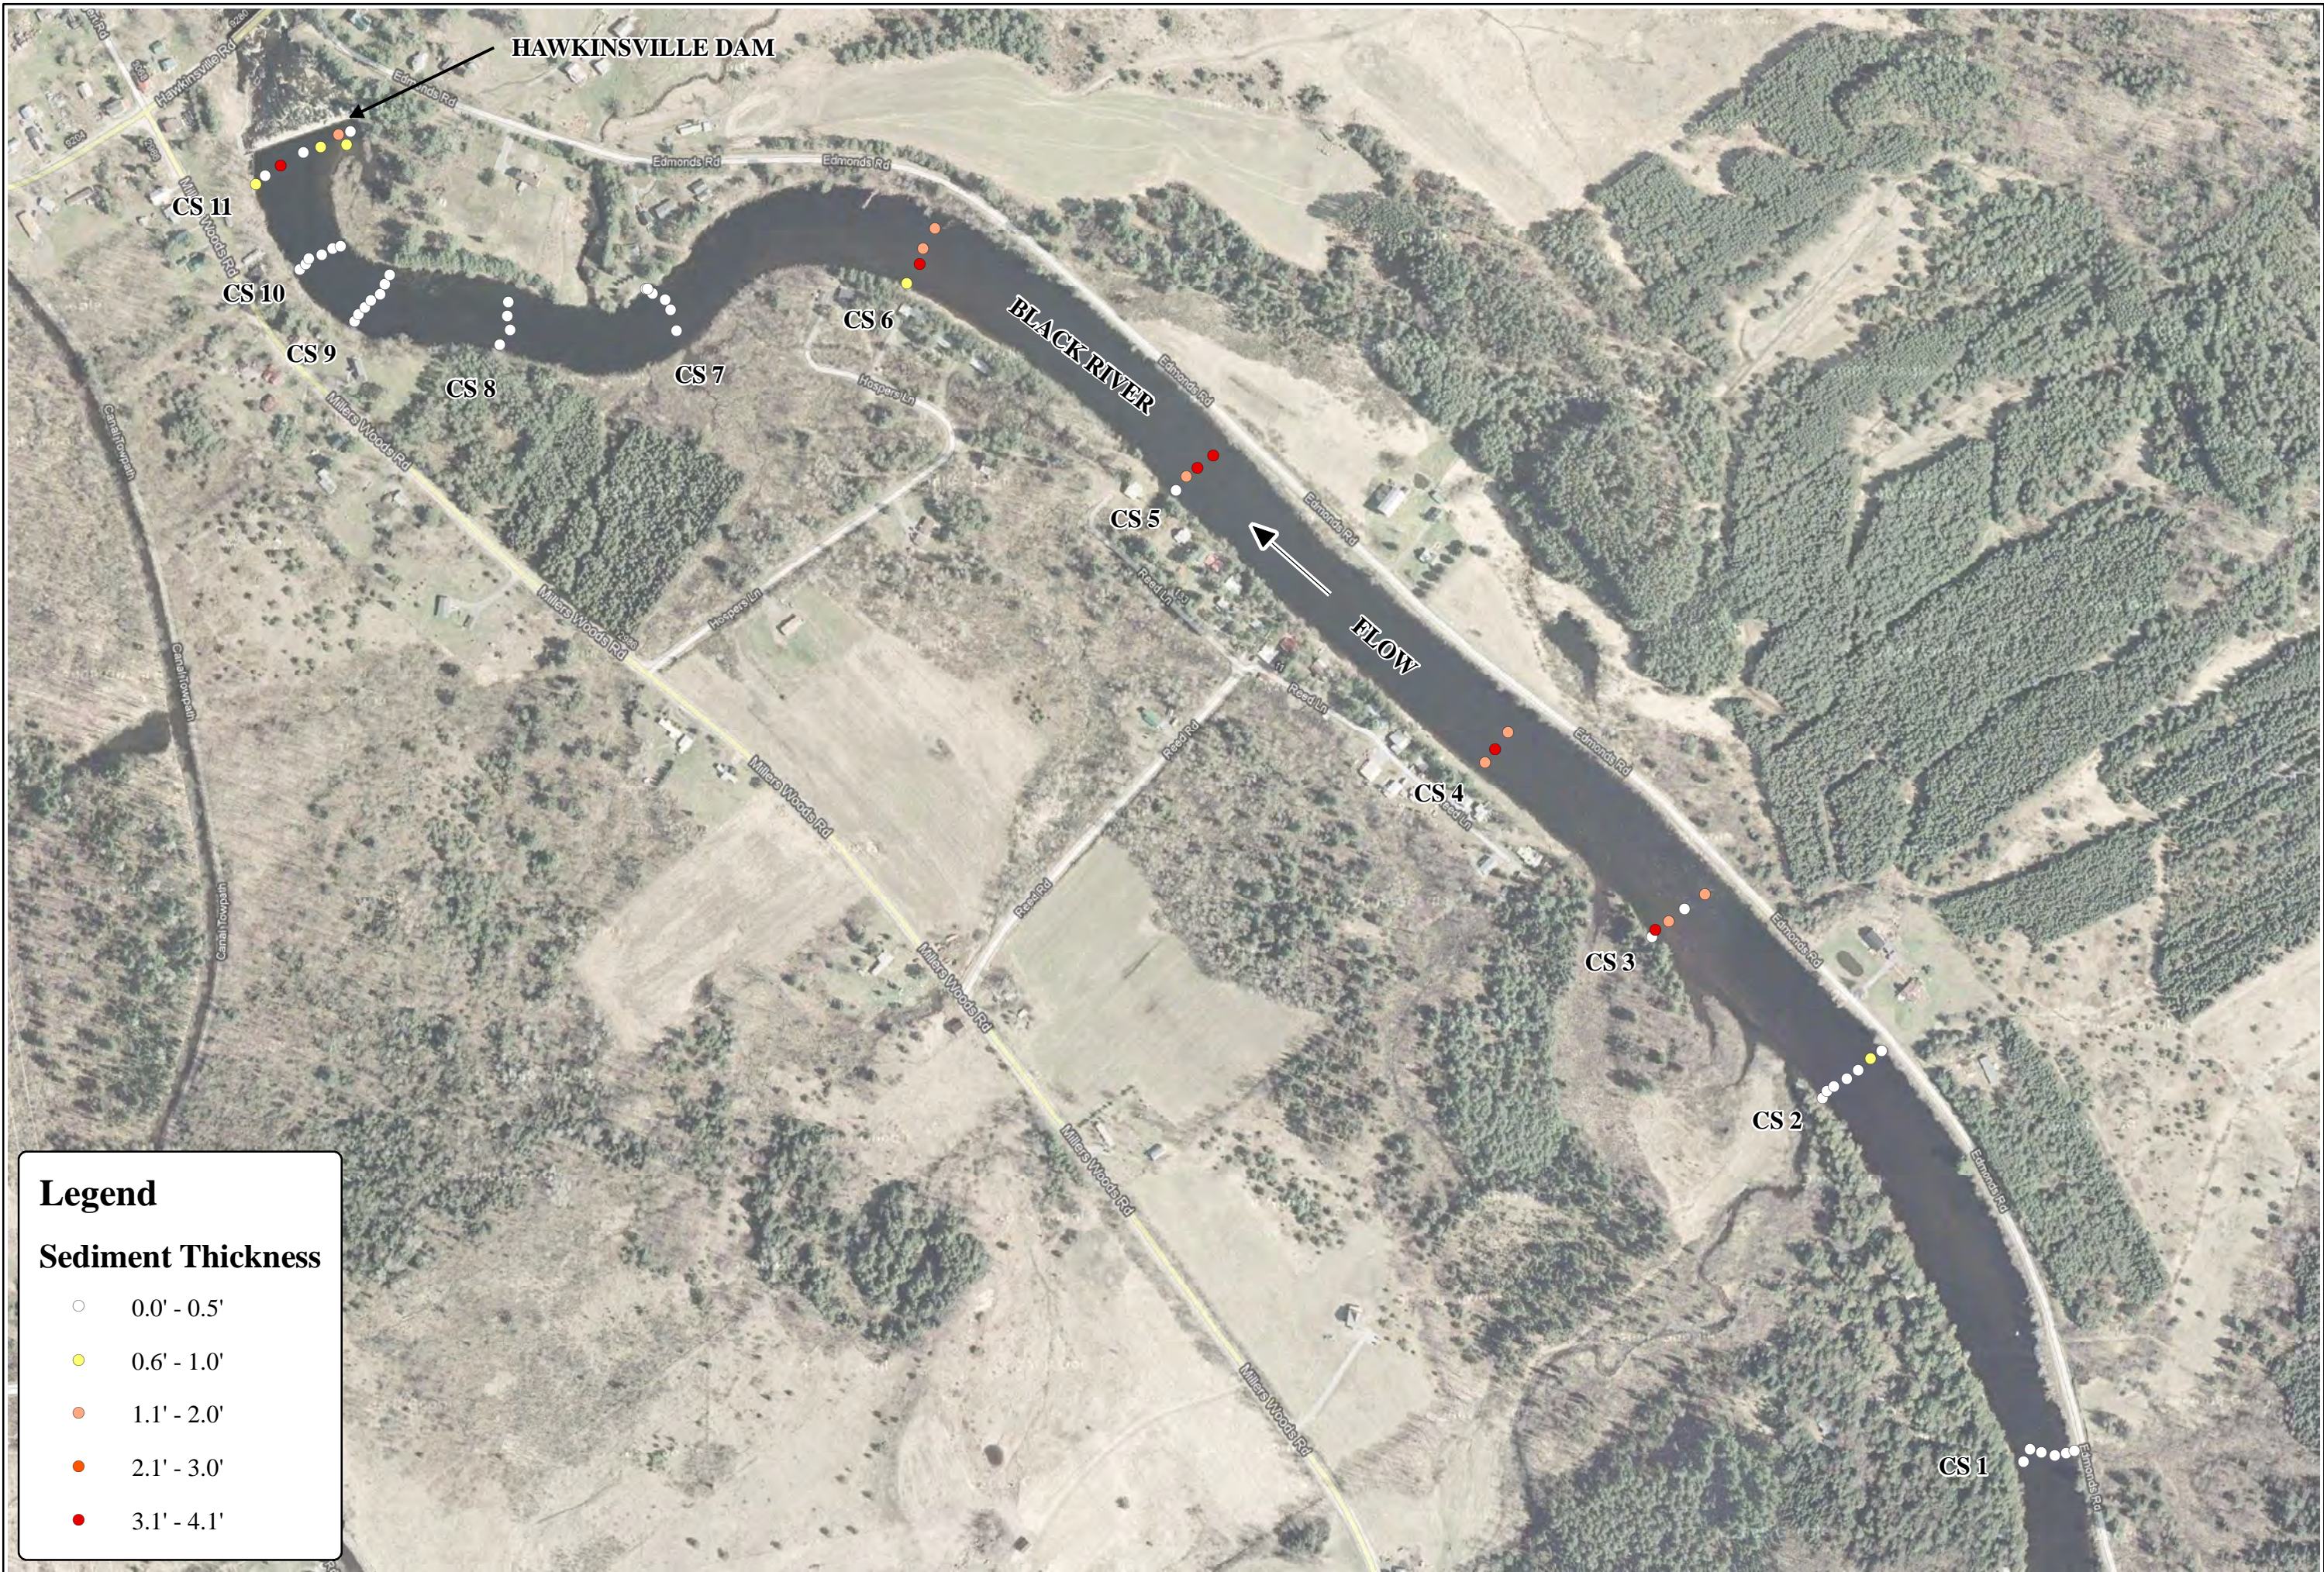
**Figure 5**

**SURVEYED SEDIMENT THICKNESS (JULY 28, 2011)**  
**ASSESSMENT OF THE HAWKINSVILLE DAM**  
**BLACK RIVER, BOONVILLE, NEW YORK**
