**ASSESSMENT OF THE HAWKINSVILLE DAM**  
**ON THE BLACK RIVER**

**BOONVILLE, NEW YORK**

March 12, 2012

MMI #3967-01

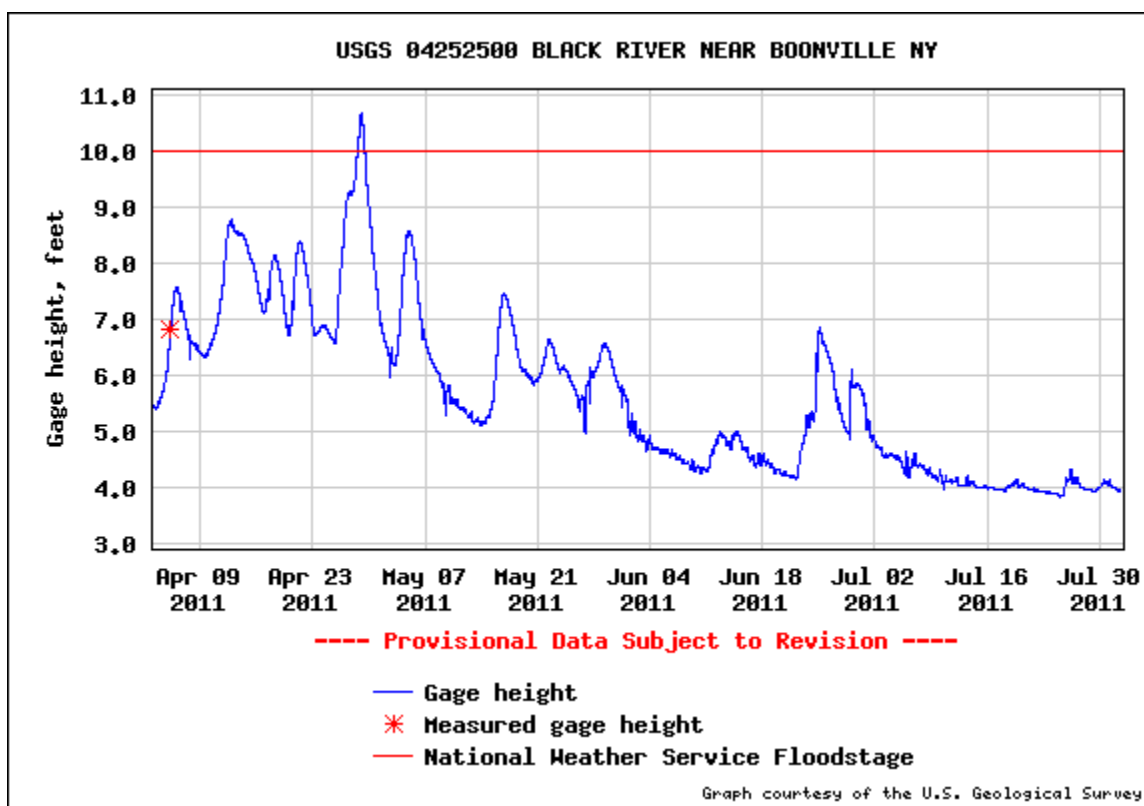
**FIGURE 2**  
**USGS Gauge No. 04252500, Black River at Boonville, New York**

The drainage area of the Black River at the Hawkinsville Dam is estimated to be 270 square miles (Gomez and Sullivan, 2006). The United States Geological Survey (USGS) has continuously operated a stream flow gauge on the Black River (Gauge No. 04252500 near Boonville, New York, Latitude: 43°30'42", Longitude: 75°18'25") approximately 3.8 miles downstream of the Hawkinsville Dam. The drainage area at the USGS gauge is larger than at the dam. As such, measured flows at the gauge provide a conservative estimate of flows at the dam. The period of record of the gauge extends back to 1911. Figure 2 shows recent flows at the Boonville USGS gauge.

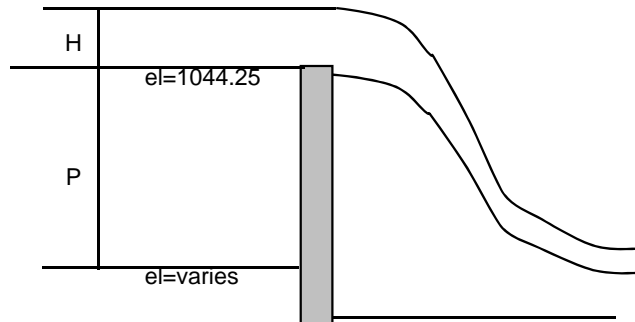
**100-Year Flood Analysis**  
**Q= 21,450 cfs      K=0.4+0.05(H/P)**

important public utilities. It was identified as not meeting the current safety requirements for such a classification. Specifically, the spillway of the dam was found to be inadequate to contain the design storm (spillway design flow, or SDF) of 150% of the 100-year flood flow, or 21,450 cfs.
