HAWKINSVILLE DAM FINAL STUDY

HAWKINSVILLE DAM PROJECT

**Hudson River-Black River Regulating District
Albany, New York**

May 2014

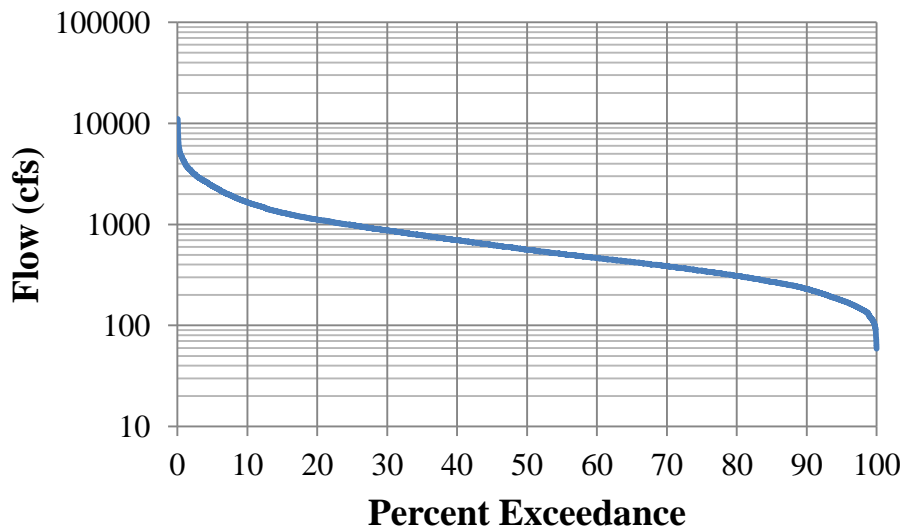
FIGURE 2-1. BLACK RIVER FLOW DURATION CURVE AT USGS GAGE #04252500

The headwaters of the Black River are in the western Adirondacks, and the river flows northwest to Lake Ontario. The river near Hawkinsville is part of the upper segment that receives run off from the Adirondacks, which results in a rapid response to rainfall events and spring snow melt. The contributing drainage area to the dam is 270 square miles (Gomez and Sullivan, 2006). The hydrology of the Black River at Hawkinsville Dam was analyzed using the U.S. Geological Survey (USGS) gage near Boonville, NY (USGS #04252500). The period of record represents a slightly larger watershed area of 304 square miles and dates from March 3, 1911, to the present day. Flow in the Black River at the Hawkinsville Dam typically ranges between 100 cfs and 10,000 cfs (Figure 2-1). Seasonal flows are typical for a northern temperate climate with similar watershed characteristics (Table 2-1).

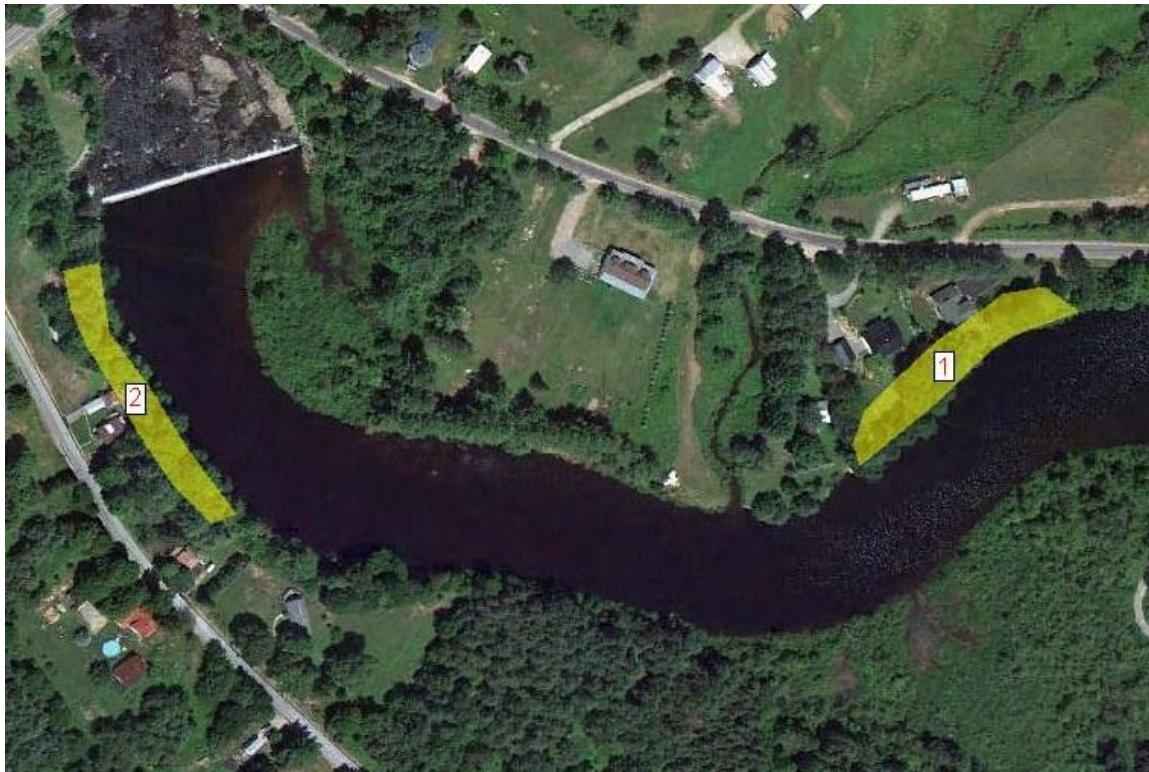
FIGURE 3-2. AREAS OF CONCERN FOR BANK INSTABILITY AFTER THE HAWKINSVILLE DAM IS REMOVED

At Area of Concern (AOC) 1 (Figure 3-2), the Black River takes a sharp turn to the west. The slope on the east bank is steep (nearly 1:1), and mature trees anchor the riverbank. If the dam is removed, the water levels will be approximately 4 feet lower, and the water velocities will increase 1 foot per second during a channel-forming flow (i.e., the 2-year reoccurrence interval). Although these changes are small, the new hydraulics could erode the slope, potentially increasing the chance for bank instability. At AOC 2 (Figure 3-2), the river takes a mild bend to the west. The bank slope and anchoring are similar to those at AOC 1. At AOC 2, the water levels will be approximately 5 to 6 feet lower and the water velocities will increase 4.5 feet per second during a channel-forming flow. These changes are more significant and pose a greater risk for bank instability. To help mitigate the risk, the left abutment of the dam will remain in place to deflect erosive flows away from the bank. In both cases, the bank should be monitored after the dam is removed. Potential engineering solutions to improve bank stability include bio-stabilization or rip-rap of the bank slope, if necessary.

Sometimes removing a dam can dramatically affect bank stability and erosion by altering the flow regime in the river. Removing the low-head Hawkinsville dam will result in relatively small changes in water surface elevation; therefore, the risk of bank instability and erosion are minimal. Two locations, however, have some risk of instability after removal (Figure 3-2). The mechanisms for bank instability are the same for both areas. At bends in rivers, the outer bend carries most of the flow, and the inner bend conveys less. This results in a greater potential for scour on the outer, bend and accumulation of sediment on the inner bend. Typically, a pool will form on the outer bend, and a point bar will form on the inner bend.

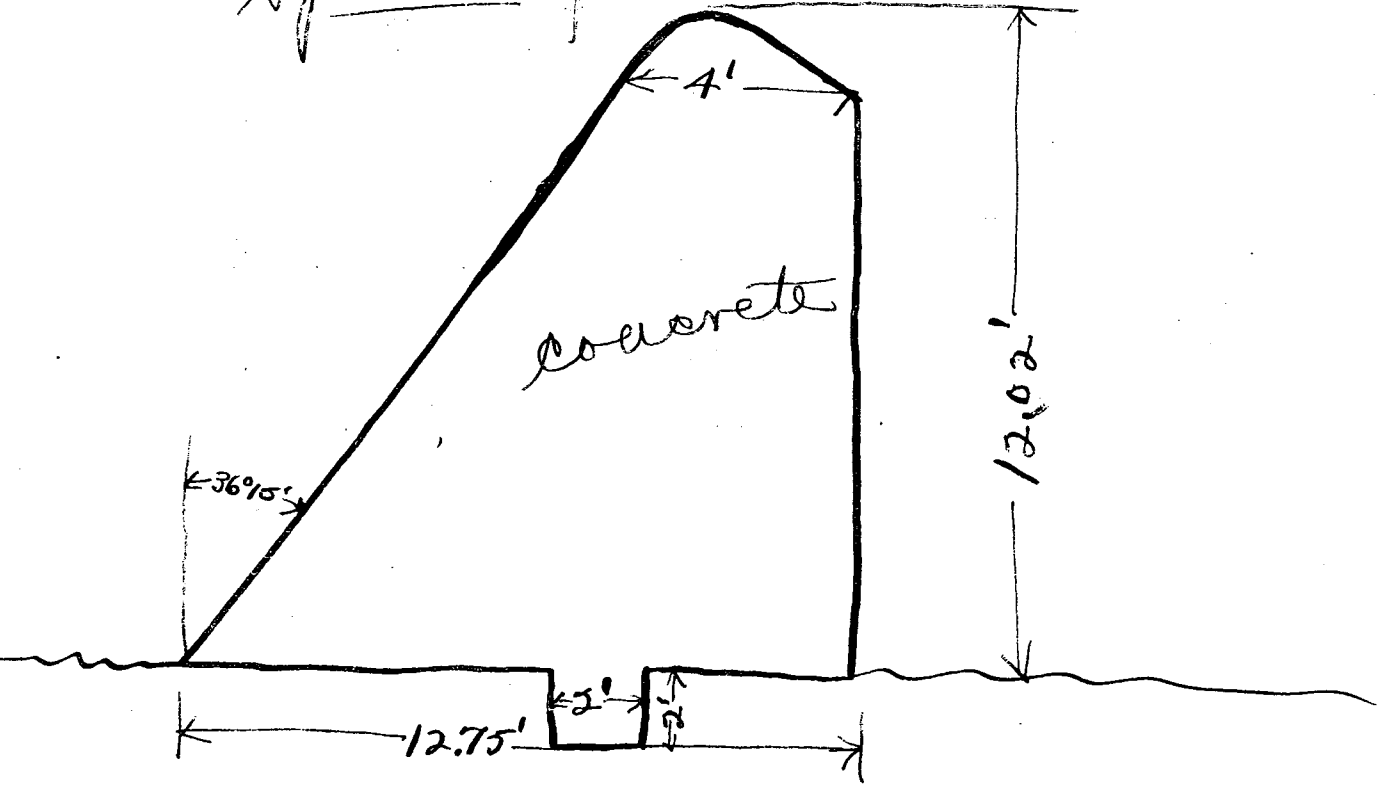
Spillway

(In the space below, make one sketch showing the form and dimensions of a cross section through the spillway or waste-weir of this dam, and a second sketch showing the same information for a cross section through the other portion of the dam. Show particularly the greatest height of the dam above the stream bed, its thickness at the top, and thickness at the bottom, as nearly as you can learn.)

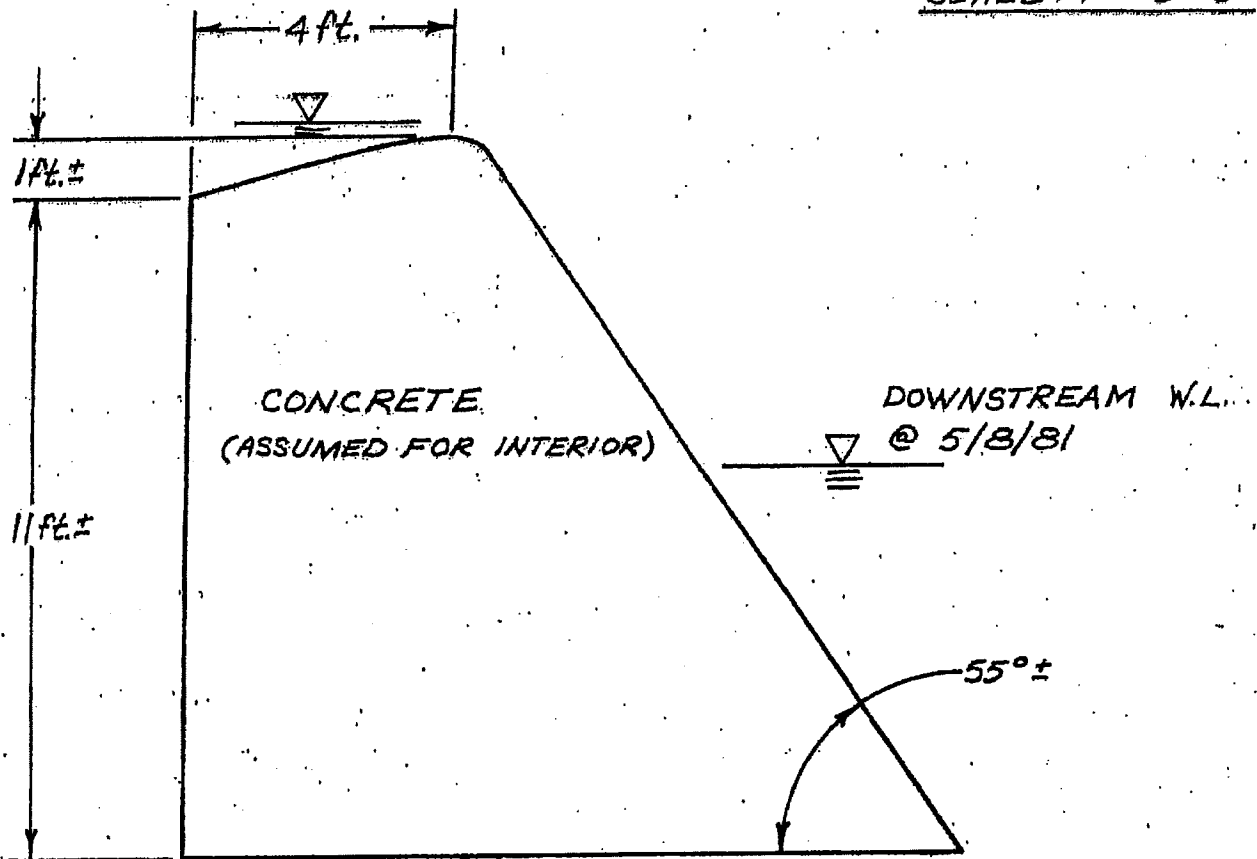
Figure 2b

PROJECT NAME HAWKINSVILLE DAM, TOWN OF BOONVILLE DATE 6/1/81
PROJECT DAM SECTION - BASED ON FIELD MEASUREMENTS PROJECT NO. _____
DRAWN BY D.F.M.

NOTE: DAM SECTION SHOWN IS BASED UPON FIELD MEASUREMENTS AT THE TIME OF A FIELD INSPECTION, 5/8/81. HEIGHT OF DAM APPEARS TO VARY, AS INFLUENCED BY ELEVATION OF FOUNDATION ROCK. SECTION SHOWN REPRESENTS MAXIMUM HEIGHT. ENTIRE DAM FUNCTIONS AS A SPILLWAY.

Figure From New York District Corps of Engineers.
Phase 1 Inspection Report, National Dam Safety Program. Hawkinsville Dam, New York. August 1981.

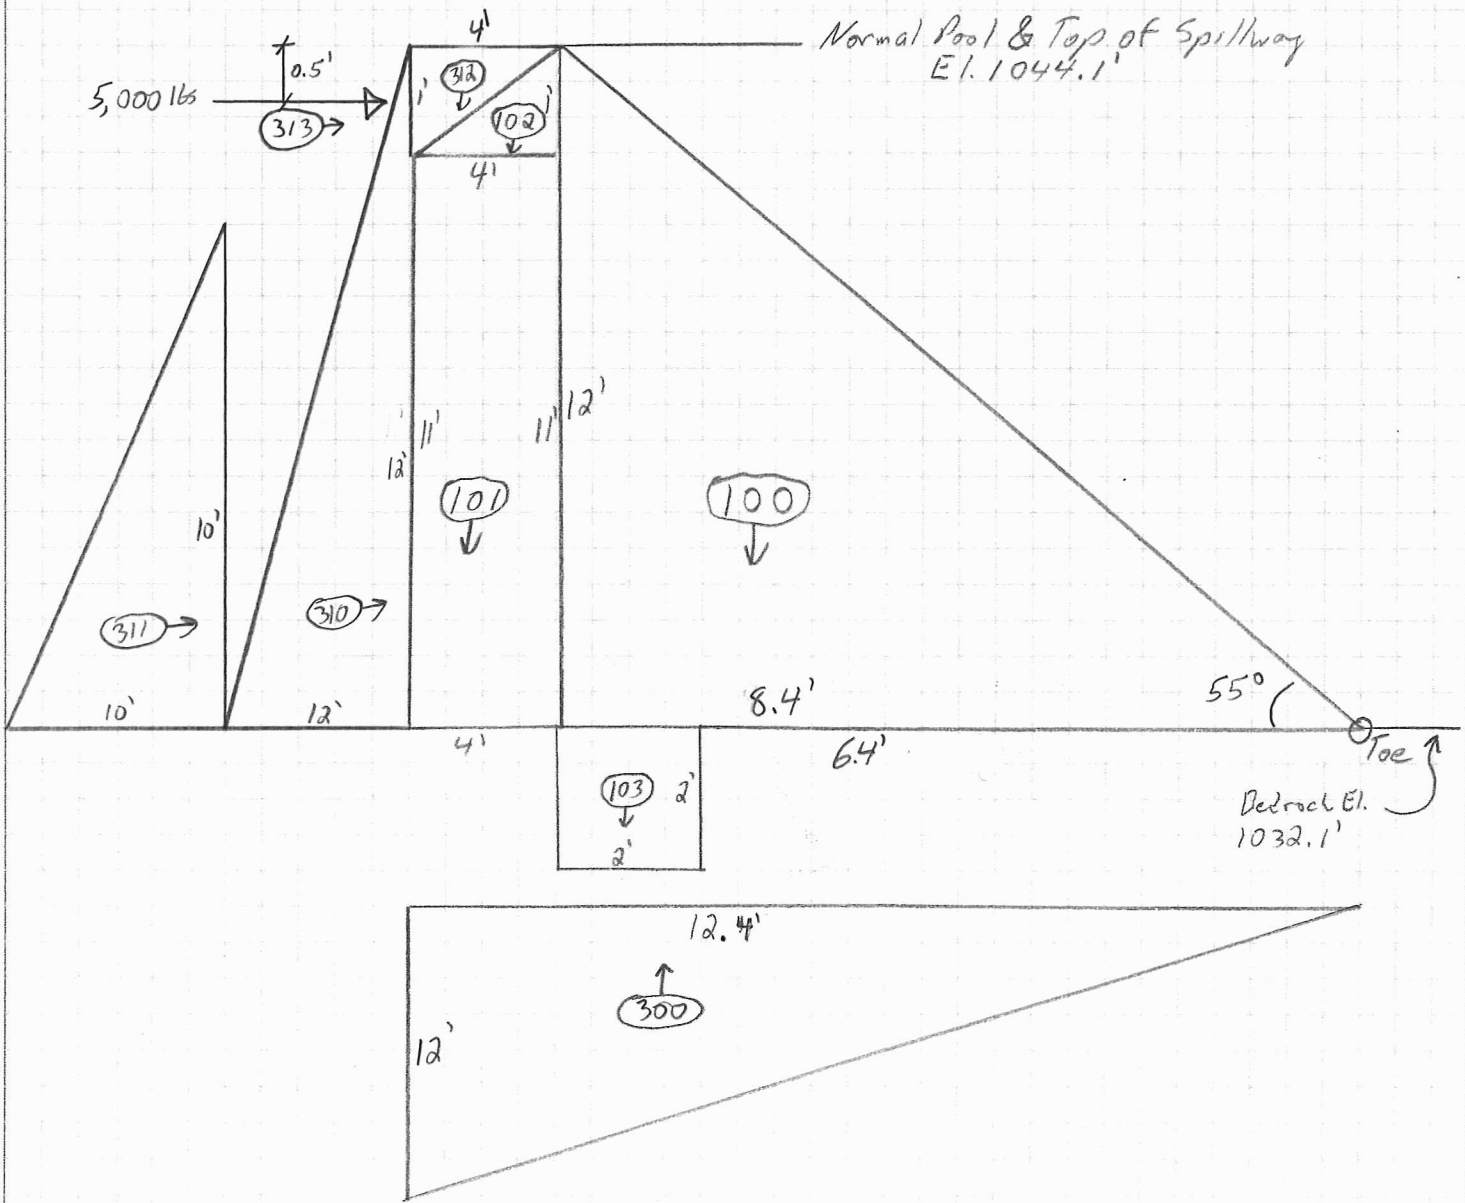
Load Case 2 : Ice Loading Conditions

- Assumed 1 ft thick Ice sheet
- Ignore advantage of sloped concrete

pool with a 5,000 pound-per-foot ice load at spillway crest, design flood (100-year), and earthquake conditions at normal pool. The stability analysis was completed using Kleinschmidt's in-house software KA Stable.

The results of the analysis determined that the dam meets NYSDEC stability guidelines for overturning and sliding under the normal pool, design flood, and earthquake cases (Table 2-3). The dam does not meet stability requirements for overturning during ice load conditions; however, the run-of-river dam is likely to have experienced annual ice load conditions similar to the ice load case during its lifespan and, in Kleinschmidt's opinion, inspection should be sufficient to deem the dam stable under ice load conditions. Appendix A provides details of the stability analysis.

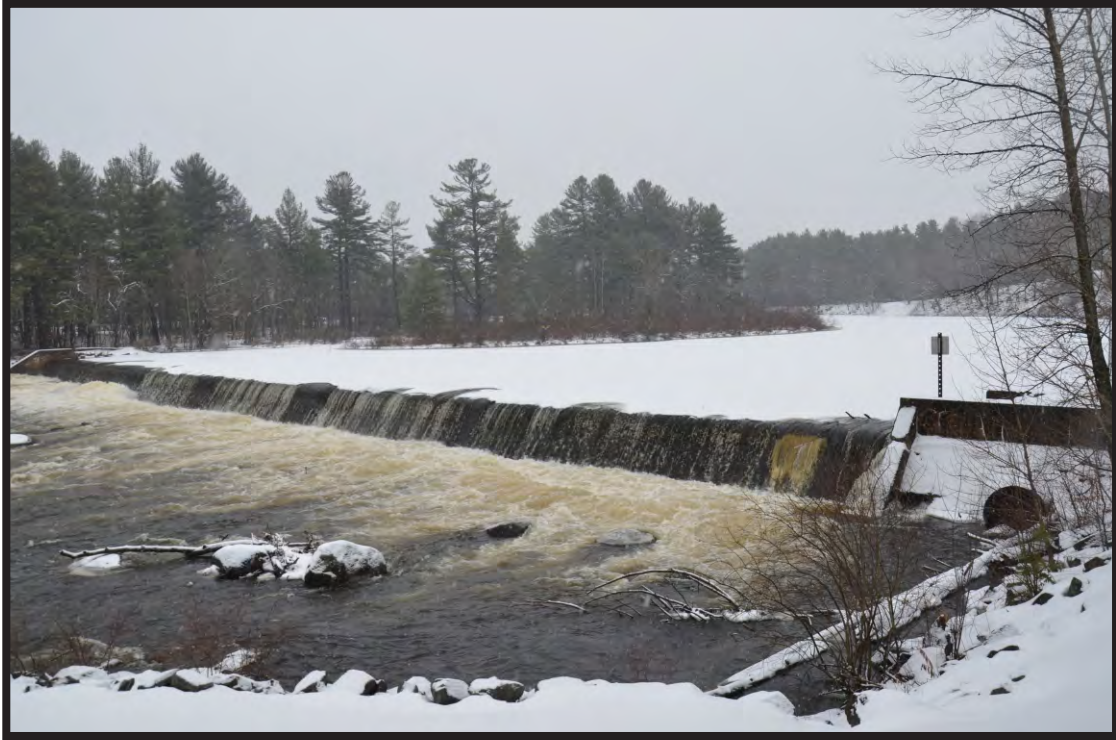
Photograph 1: Hawkinsville Dam, View to Southeast

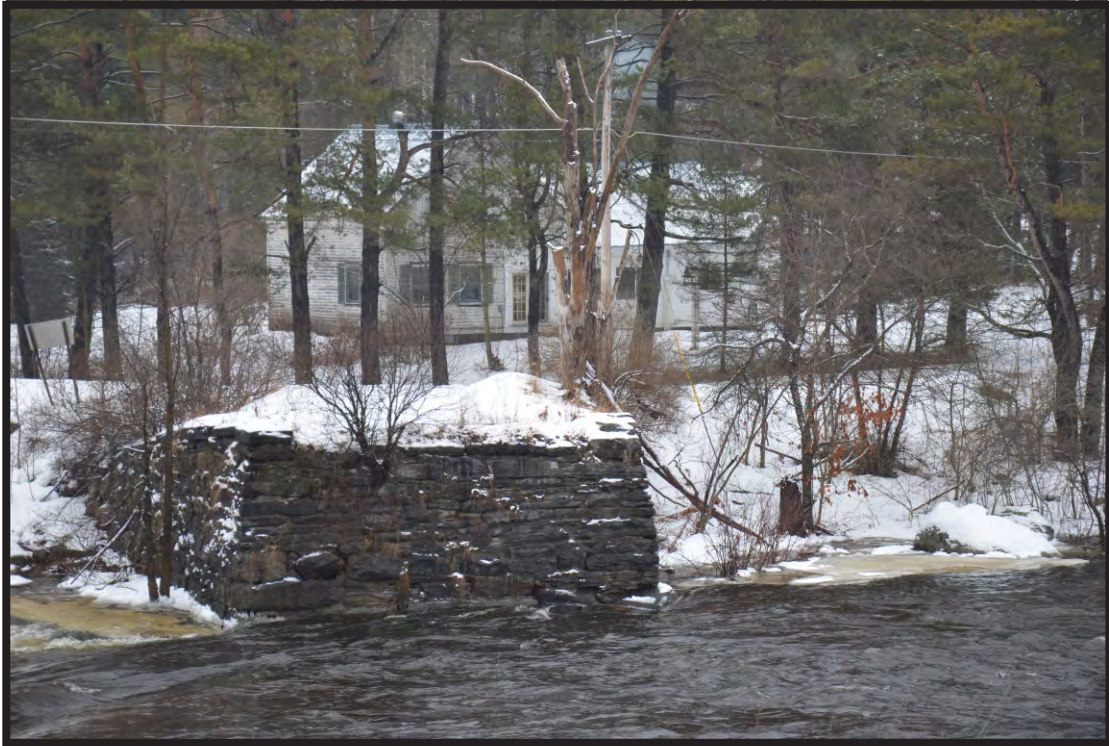
Photograph 2: Historic Bridge Abutment, View to East

There are two historic structures within the survey area. The Hawkinsville Dam, constructed in 1915, and the architectural remains of a stone bridge abutment. The stone abutment is located downstream from the dam and it appears to have once supported a bridge that connected Edmonds Road to Hawkinsville Road (Appendix A, Photograph 2).

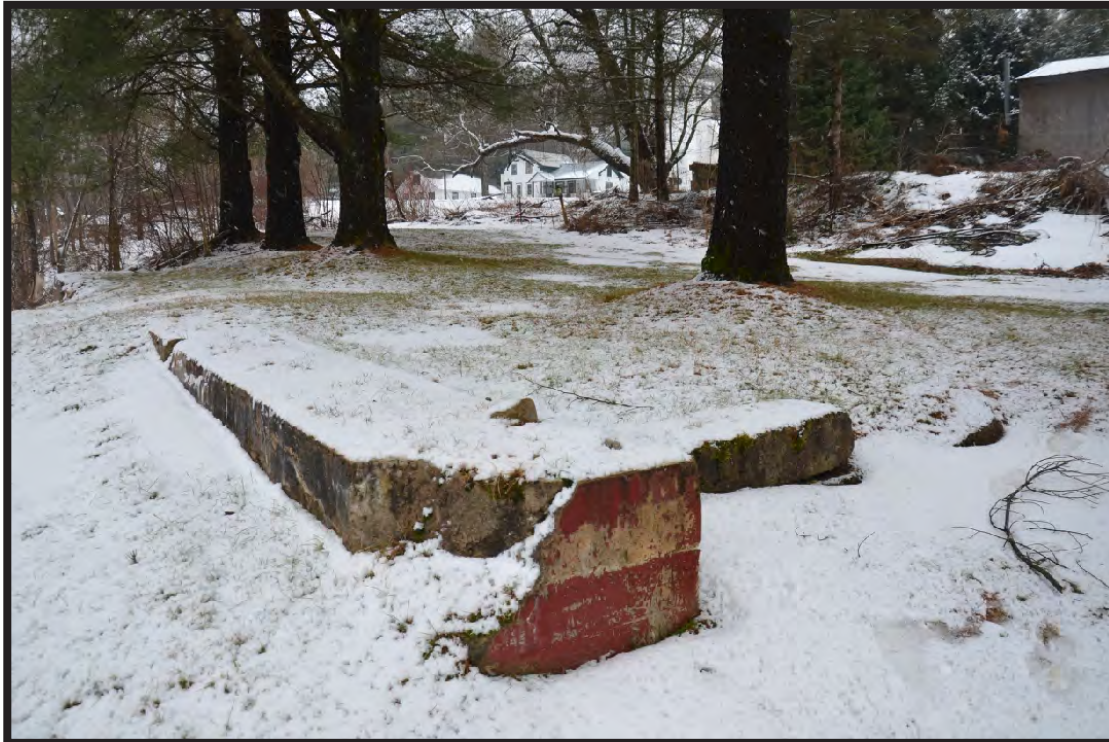
Photograph 6: Foundation Remnants, Brandt Excelsior Company,
Site 06504.000097, View to South

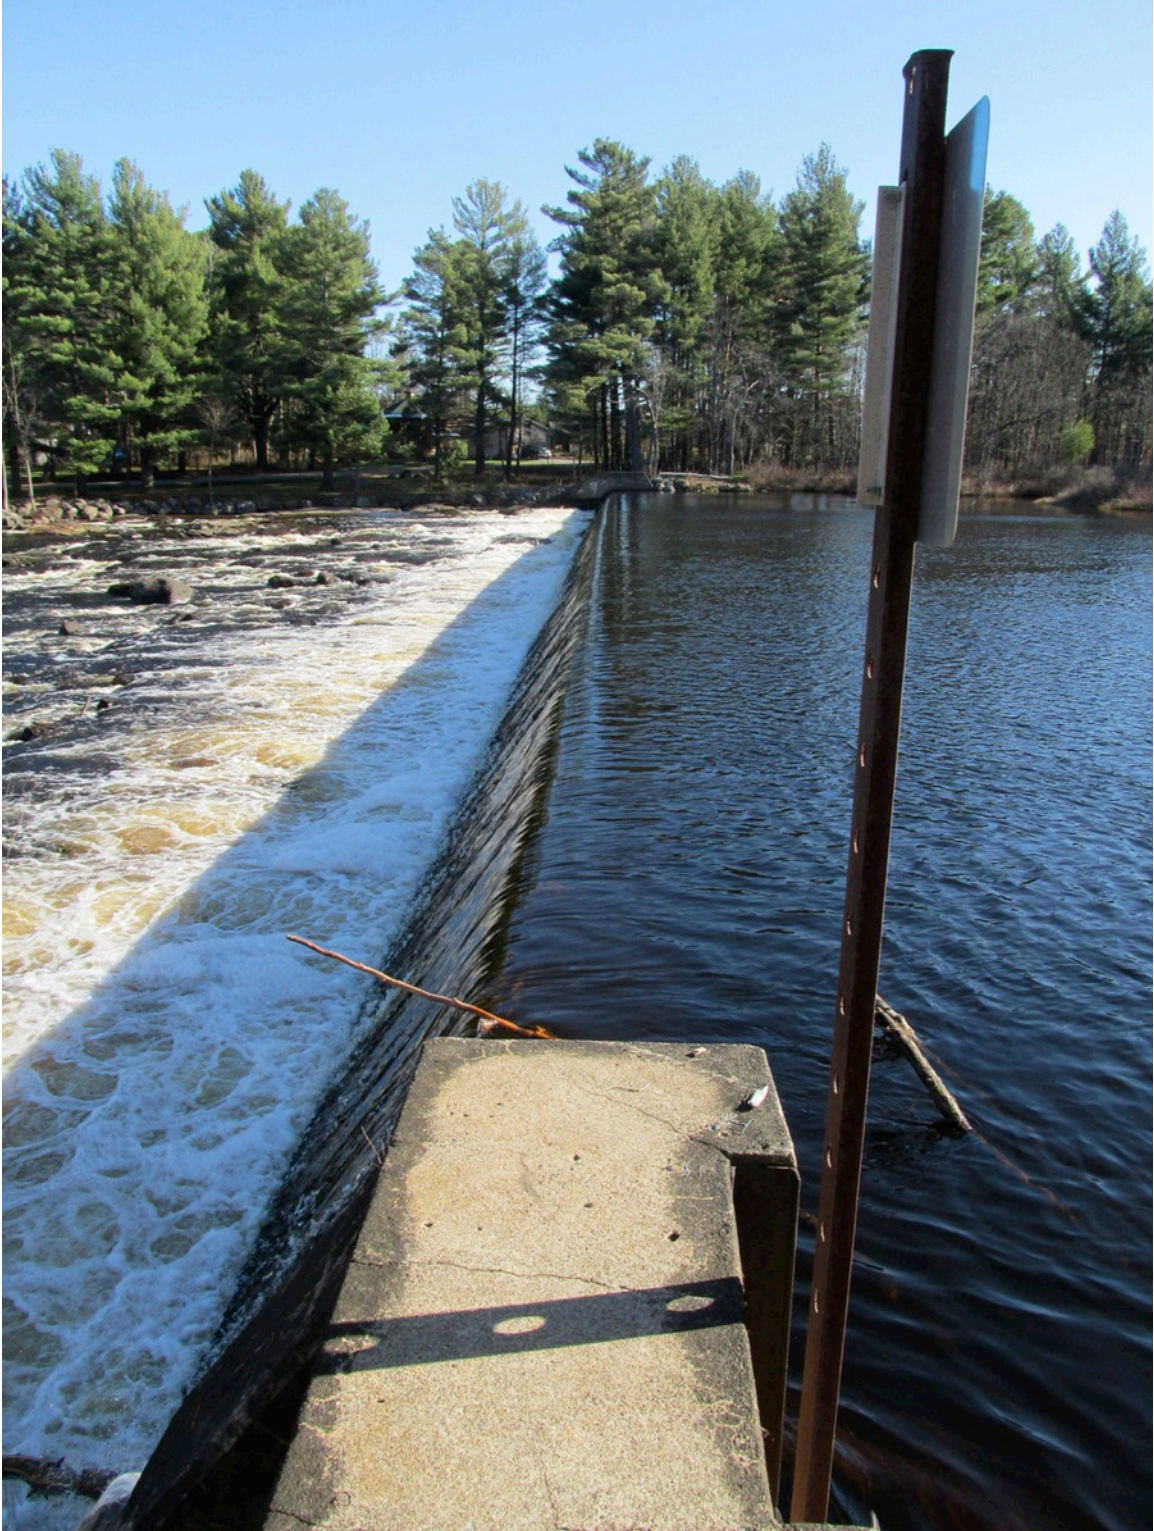
Figure 6. Crest of dam looking E, 2013.

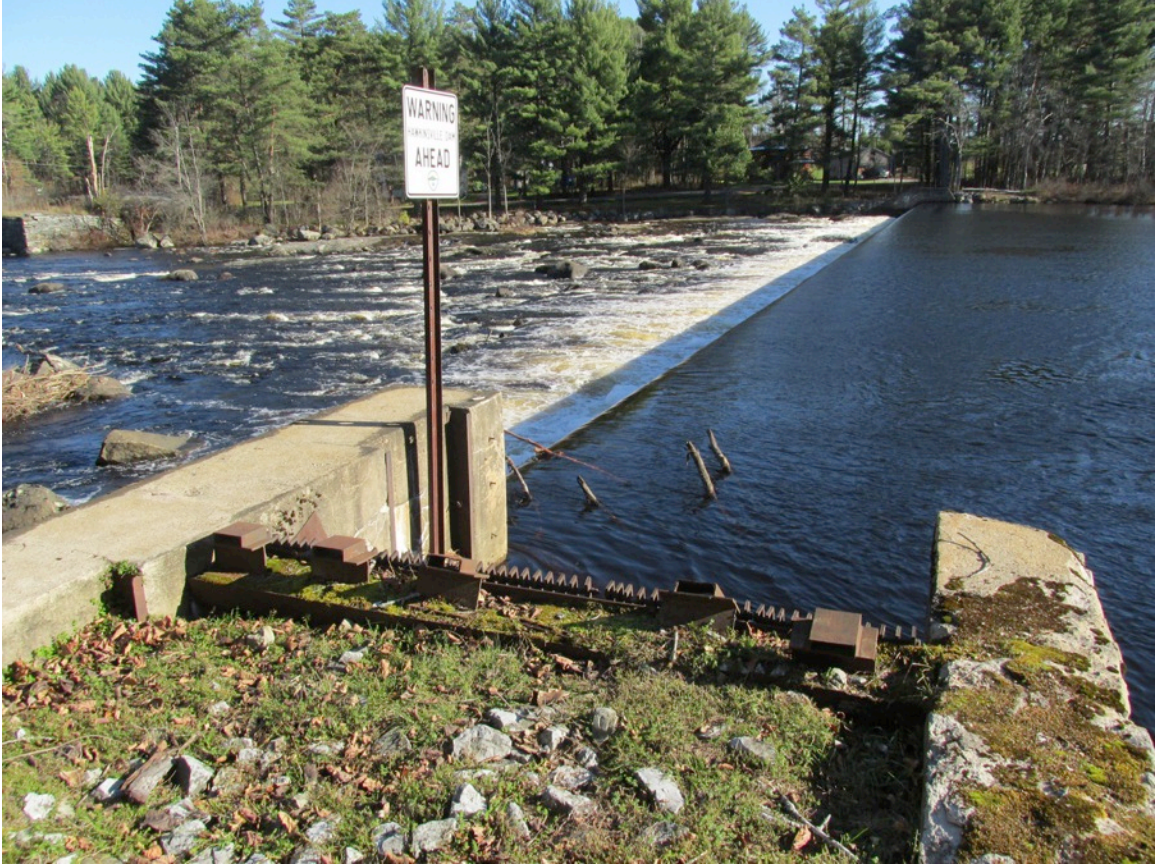
Figure 7. Dam and intake looking NE, 2013.

The dam was designed and permitted for the generation of power, with a concrete intake on the left (west) side of the dam. The intake fed water to a penstock that originally measured 5'-10" in diameter. The Brant Excelsior Company factory was located on the west side of the Black River, immediately downstream of the dam on the south side of Rt. 61. An undated postcard shows the factory as a one and one-half story frame building with a gabled roof, above a raised basement where the ground slopes down to the river (Figure 4). An auxiliary building extended to the north from the main factory building. This building was built in 1929, when the original mill was destroyed by fire. A slightly larger penstock, measuring six feet in diameter, replaced the original penstock in 1959 (Ryder 1966). The factory was closed in 1966. No evidence was found during the present research to indicate that the dam has been replaced or significantly altered.

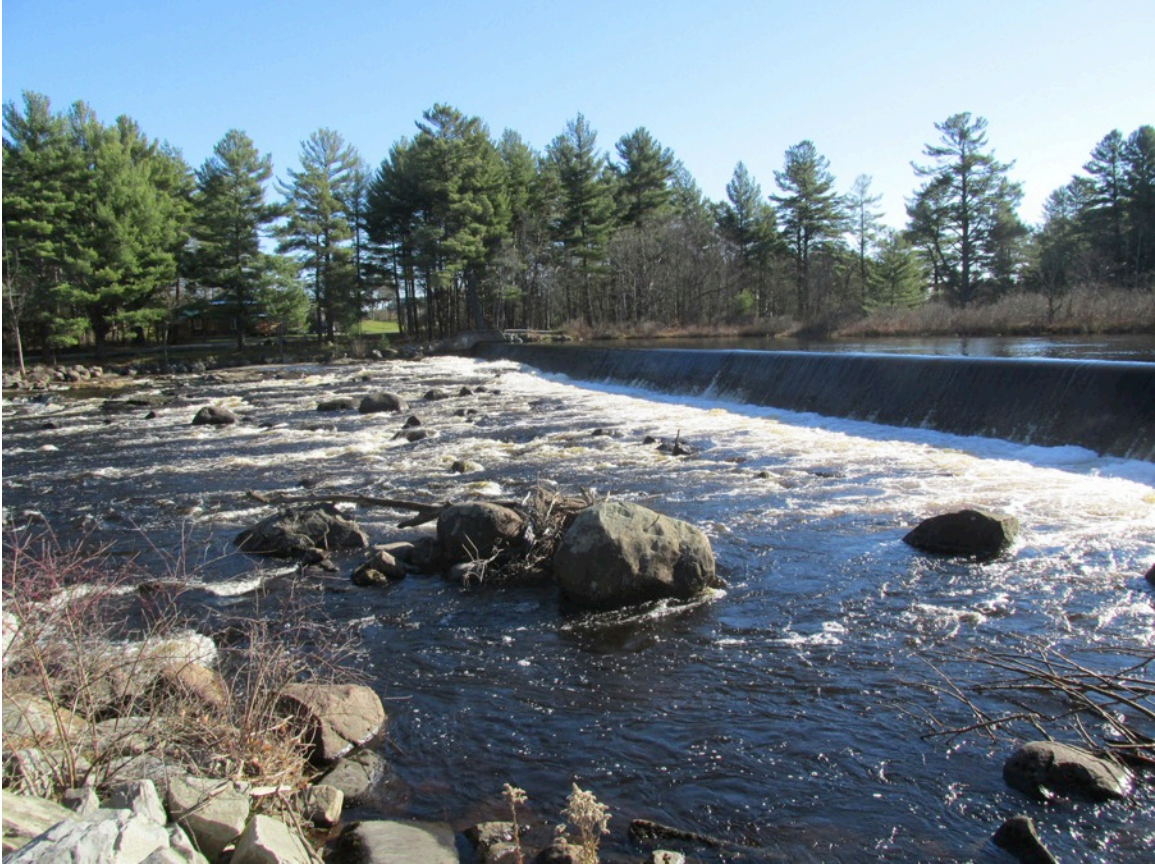
Figure 8. Downstream face of dam looking SE, 2013.

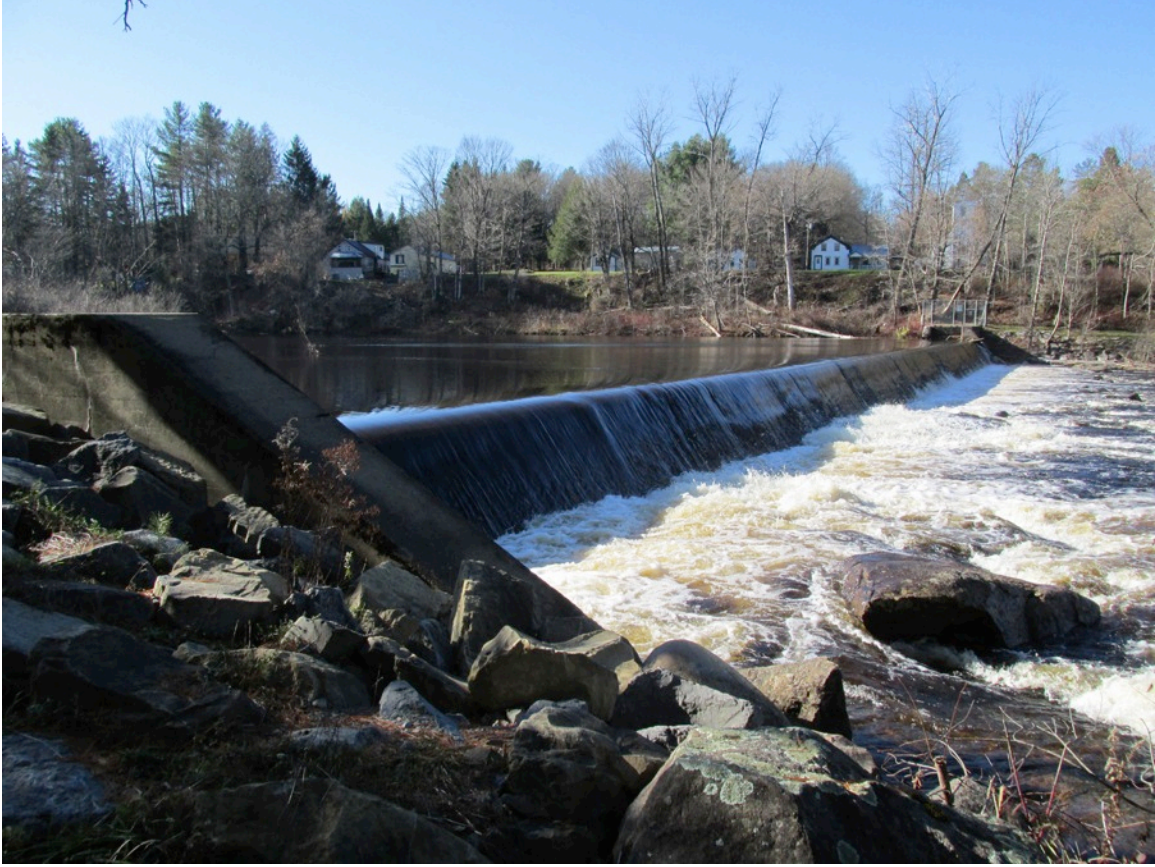
Figure 9. Downstream face of dam looking SW, 2013.

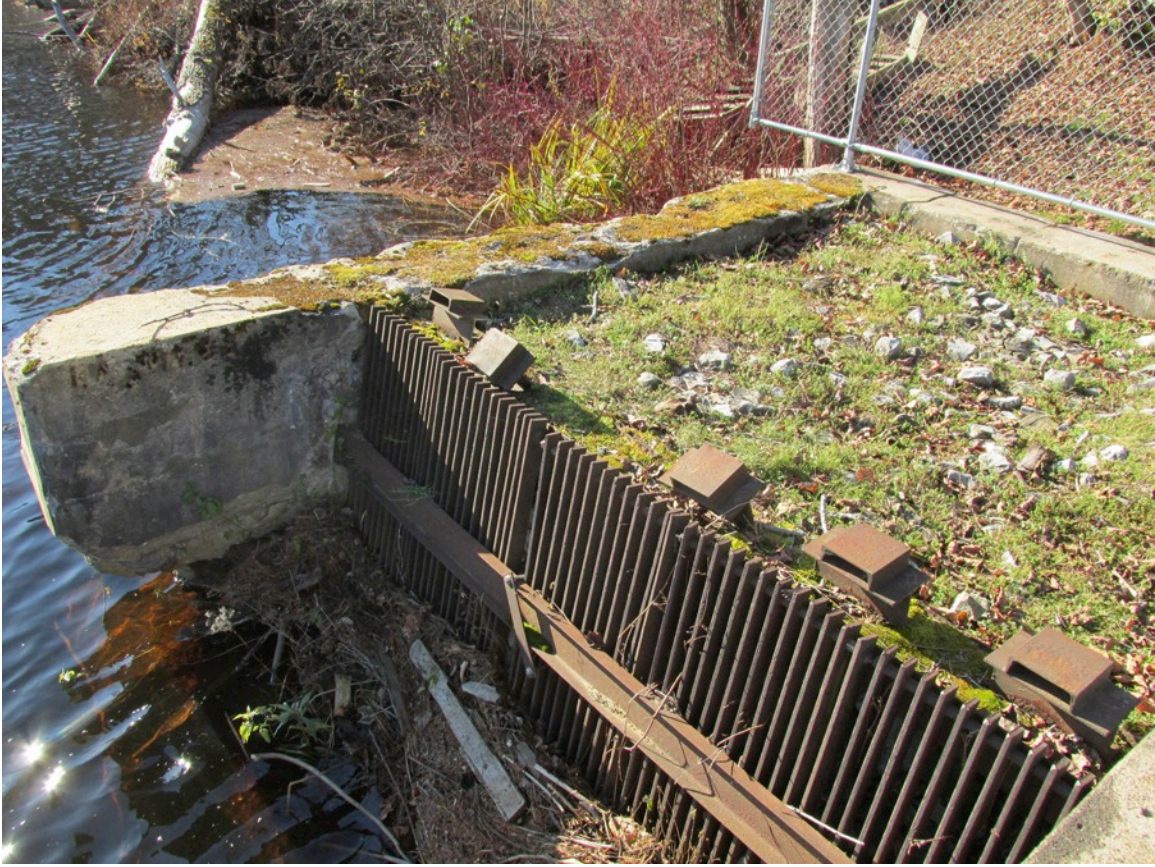
Figure 10. Intake detail, 2013.

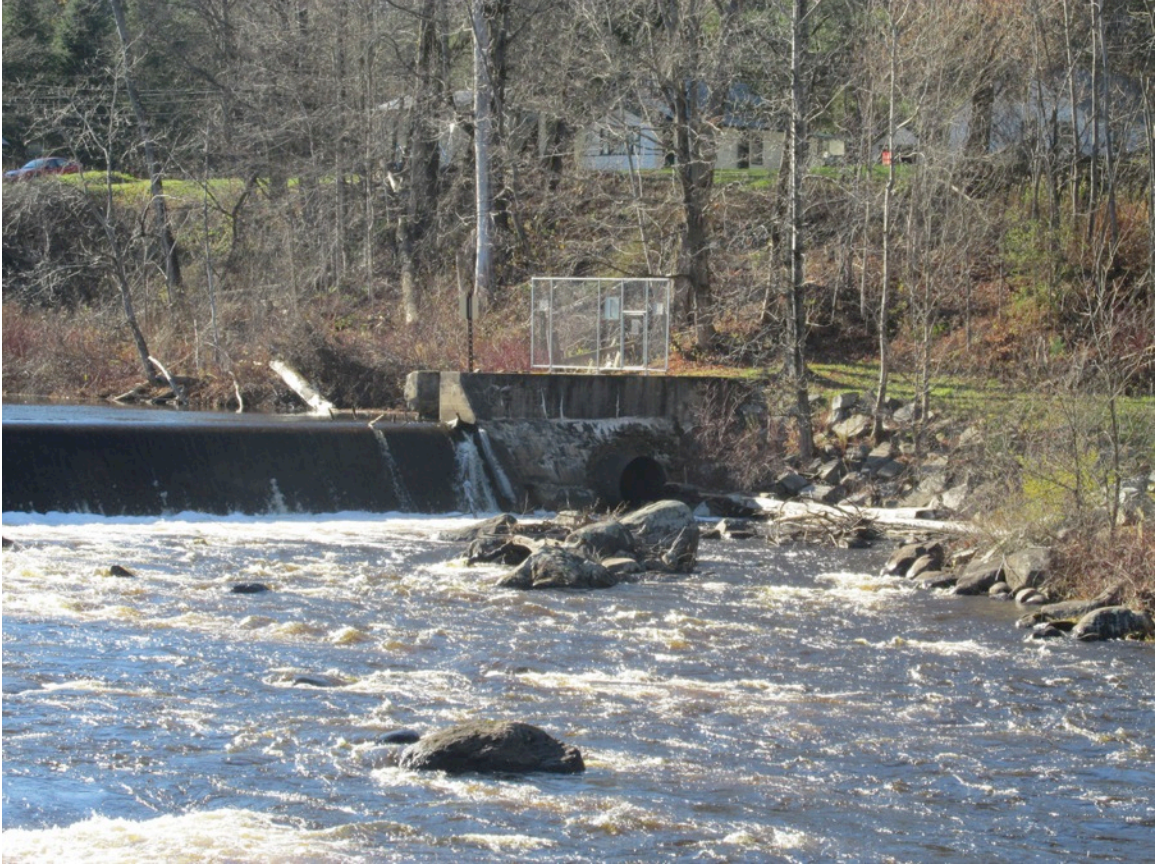
Figure 11. Downstream face of intake, showing penstock outlet.

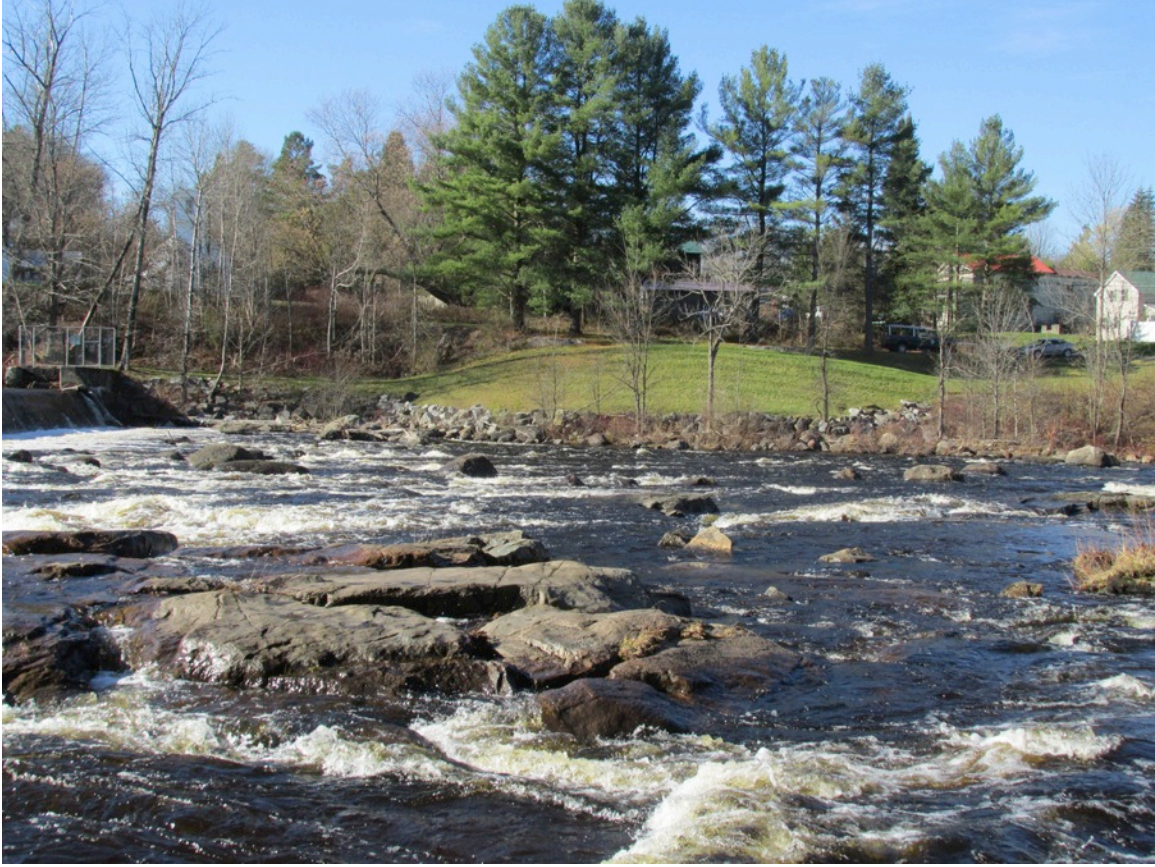
Figure 12. Former factory site looking SW, 2013.

As noted above, the Brant Excelsior factory closed in 1966, and all of the equipment and machinery were removed at that time. The building remained standing for many years, but is now gone and the land where it stood has been re-graded. Only a small portion of the concrete foundation remains to indicate the location of the factory. Figures 12 and 13 present views of the former factory site.

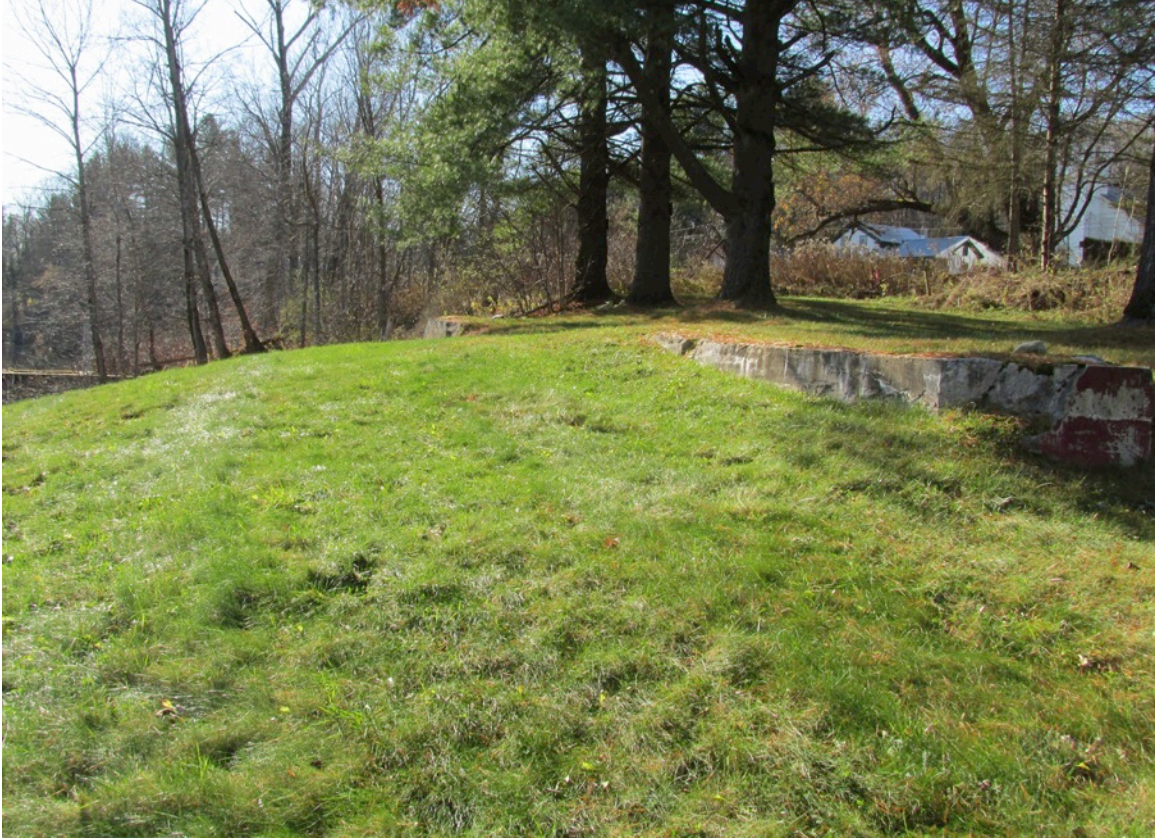
Figure 13. Former factory site, foundation detail, 2013.
